Trouble shooting & Maintenance Guide

Release R210

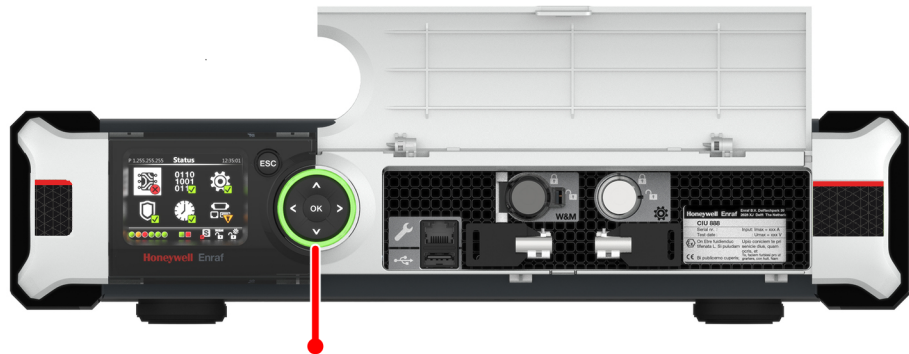
FIGURE 1-1

The ring of light located at the front of the CIU 888 indicates high level statuses of the CIU 888 (see FIGURE 1-1).

CIU 888: Ring of light

Status	Color	Movement
Starting up	Blue	Continuously
Normal, running	Green	Continuously
Critical error/failure	Red	Continuously
Warning	Orange	Continuously

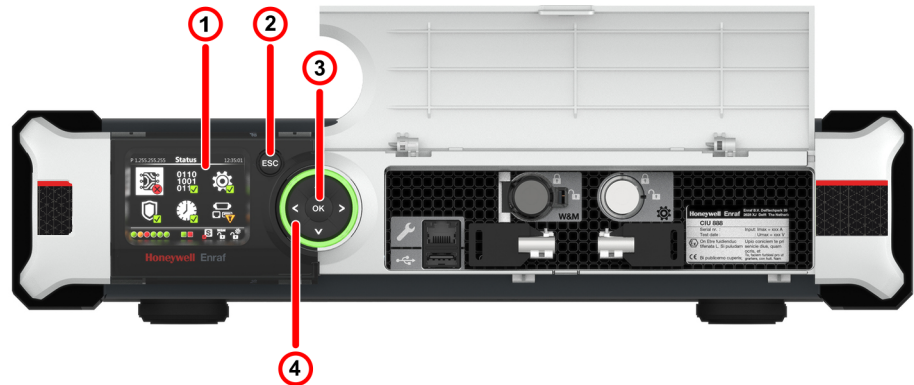
The CIU 888 display located at the front of the CIU 888 gives users access to various screens for monitoring and diagnosing the health of the CIU 888 and the connection status of the gauges connected to the CIU 888. Users can scroll through the various screens and confirm or cancel actions using the display keys (see FIGURE 1-2).

| 1. CIU 888 Display | 3. OK key |

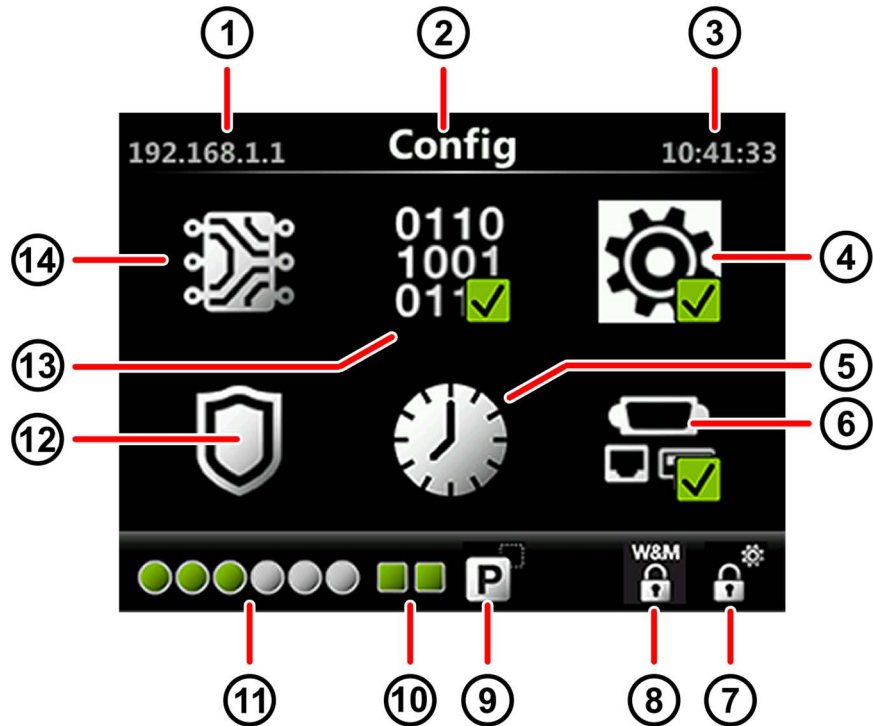
The Status Dashboard is the main display screen for monitoring the overall health of the CIU 888 and the connected gauges, and for accessing the various CIU 888 display screens (see FIGURE 1-3).

FIGURE 1-3 CIU 888 display: Status Dashboard

No.	Item	Description
1	IP address	Displays the IP address of the service port of the CIU 888. Note: The IP address before commissioning CIU 888 will be 0.0.0.0.
2	Display name	Displays the name of the option currently selected in the Status Dashboard.
3	Time	Displays the local system time, taking into account the time zones and daylight savings. The time is displayed in the format 'hh:mm:ss', where 'hh' is hours, 'mm' is minutes and 'ss' is seconds. The time can be configured during commissioning/configuration of the CIU 888 using Ensight Pro. See the <i>Configuration Manual CIU 888 (Part No. 4417593)</i> for more information.
4	Configuration option	Gives access to display screens enabling users to reset the CIU 888 to the factory defaults, and to setup redundancy. See section 1.4 for more information.
5	Clock option	Not supported currently.
6	Ports option	Gives access to detailed information for the communication ports, i.e. serial Host ports and option slots. See section 1.2.2 for more information.

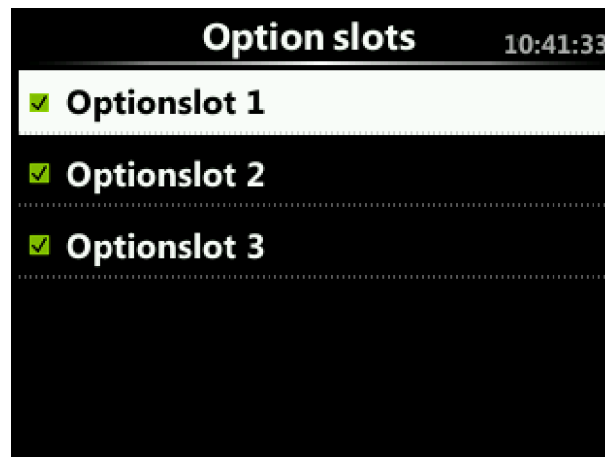
FIGURE 1-4 CIU 888 display: *Option Slots* screen

The *Option Slots* display screen provides a list of all physically available option slots and provides quick feedback on the overall health of the individual option slots by means of an icon next to the option slot name.

1. Highlight the **Ports** option in the Status Dashboard using the display keys. Next, press the **OK** display key.
The *Option Slots* screen is displayed (see FIGURE 1-4).

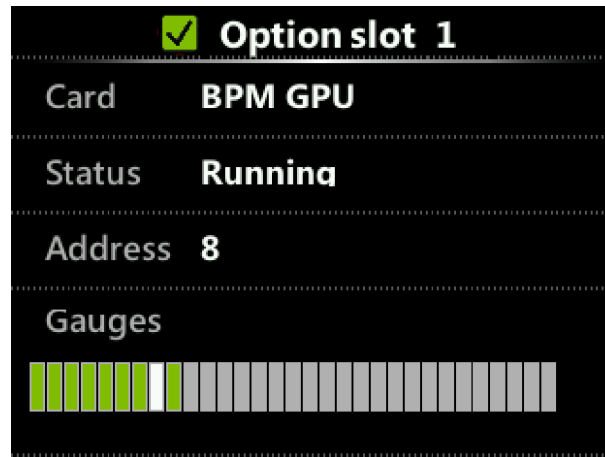
FIGURE 1-5

- Highlight the option slot for which you want to view the status using the display navigation keys. Next, press the **OK** display key. The *Option Slot* screen is displayed (see FIGURE 1-5). The name of the selected option slot is shown at the top of the screen preceded by the health state of the option slot.

CIU 888 display: *Option Slot* screen

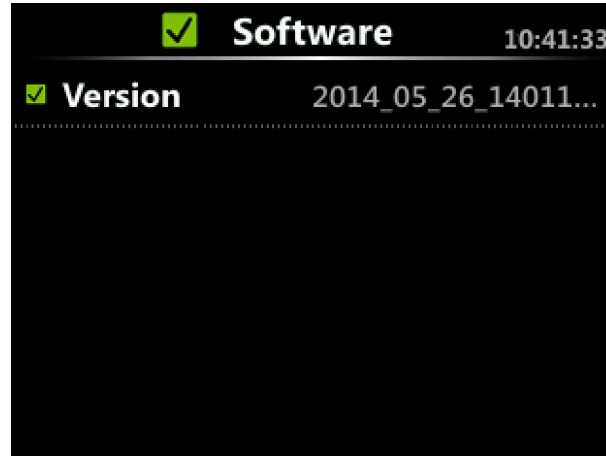
FIGURE 1-6

The *Software* screen is displayed, showing the version of the CIU 888 display software (see FIGURE 1-6).

CIU 888 display: *Software* screen

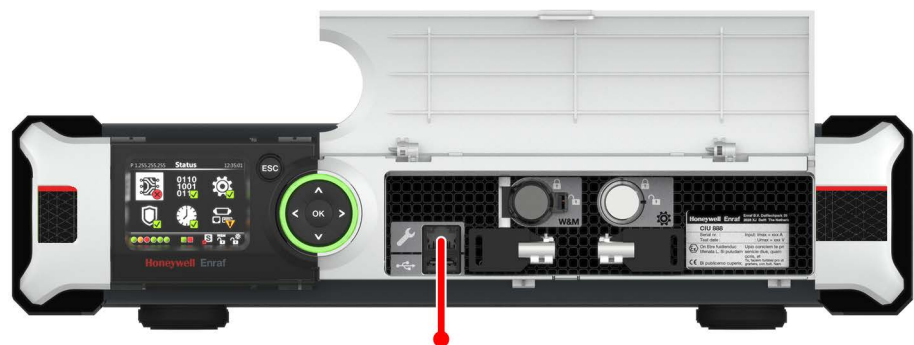
FIGURE 1-7

1. Connect the PC or laptop to the Service port of the CIU 888 using the Ethernet cable. The Service port is located at the front of the CIU 888 (see FIGURE 1-7).

CIU 888: Service port

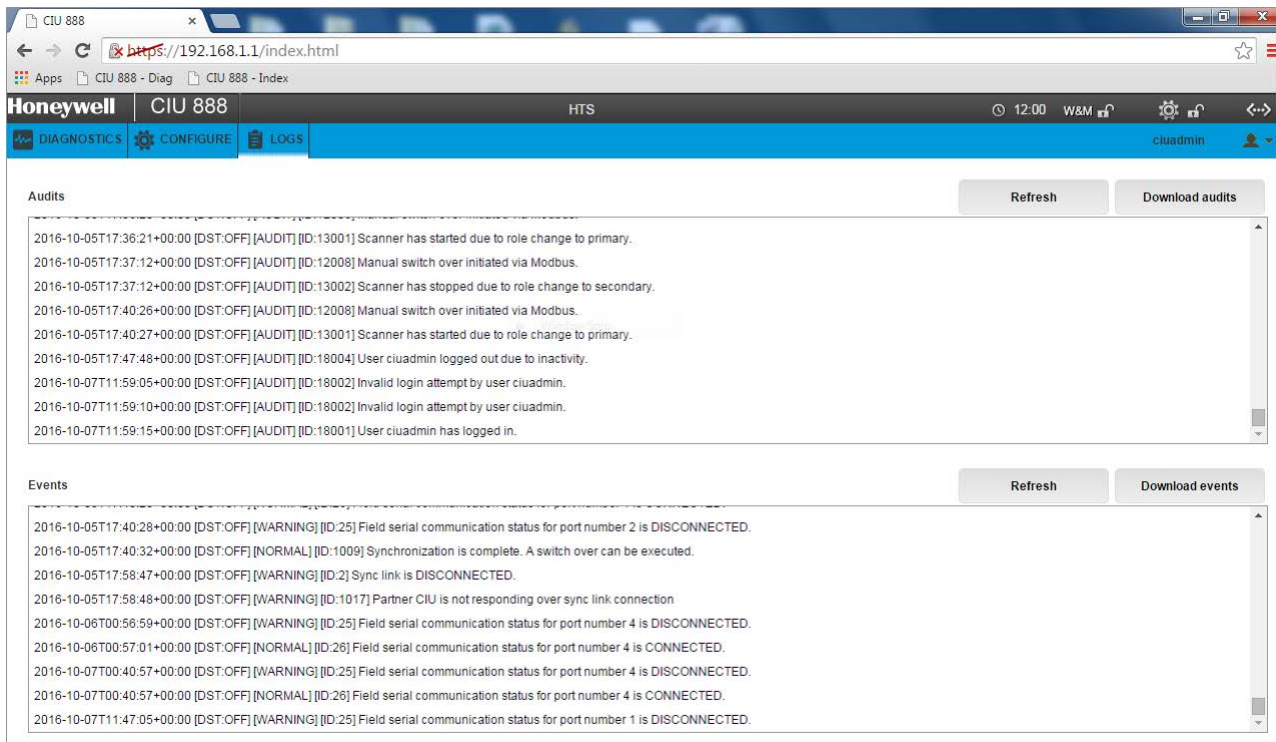
FIGURE 1-11

1. Select **Logs** in the *Section* menu bar.
The *Logs* window is displayed (see FIGURE 1-11).

Logs window

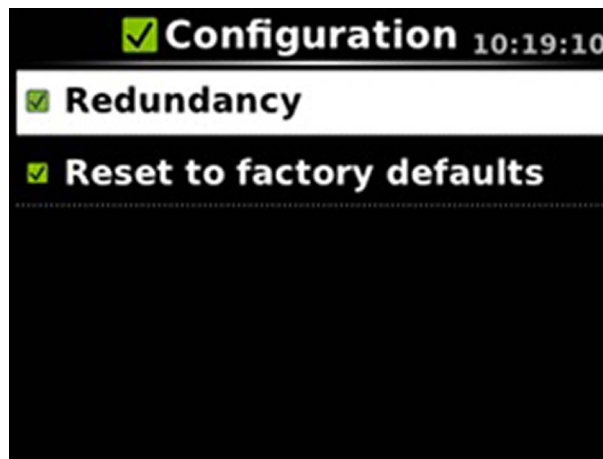
FIGURE 1-12

The *Configuration* screen is displayed (see FIGURE 1-12).

CIU 888 display: *Configuration* screen

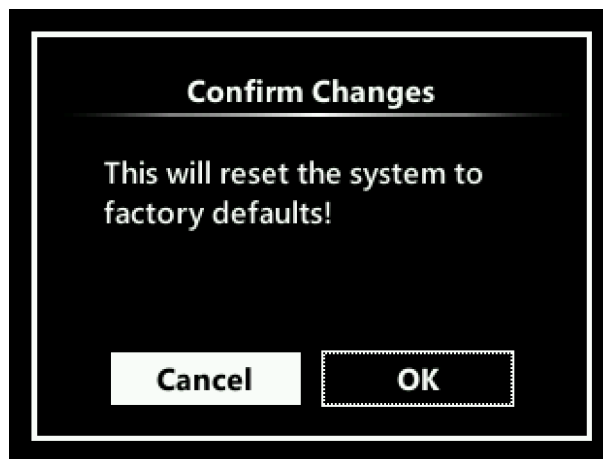
FIGURE 1-13

2. Highlight the **Reset to factory defaults** option using the displays keys. Next, press the **OK** display key.
The *Confirm Changes* screen is displayed (see FIGURE 1-13).

CIU 888 display: *Confirm Changes* screen (Reset to factory defaults)

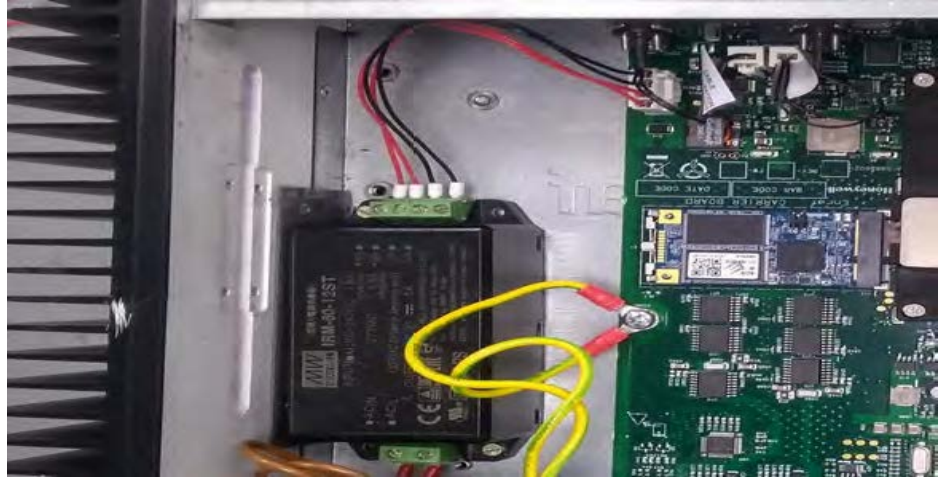
FIGURE 3-1

- c) Check if the cable connecting the internal 12V power supply and the carrier board is fine. If it's damaged, get it replaced.

CIU 888: Power Supply Cable

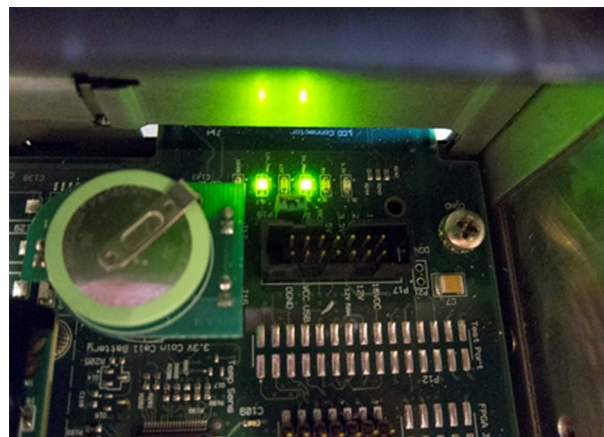
FIGURE 3-2

- b) Check the start-up sequence. The correct start-up sequence is as follows:
- i. The first two LEDs (12 Volts and 5 Volts) light up (see FIGURE 3-2).

CIU 888: First two power LEDs of carrier board light up

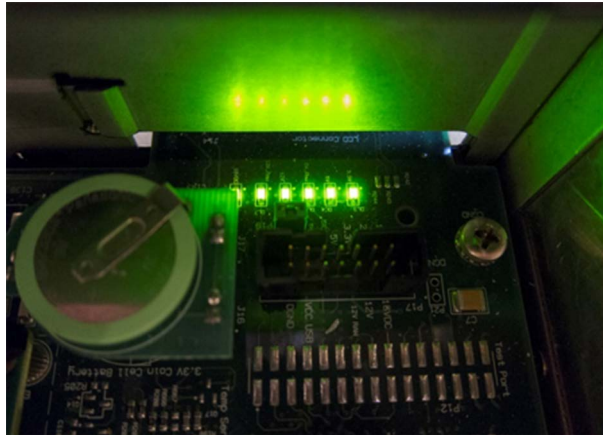
FIGURE 3-3

iii. All six LEDs light up (see FIGURE 3-3).

CIU 888: All six power LEDs of carrier board light up

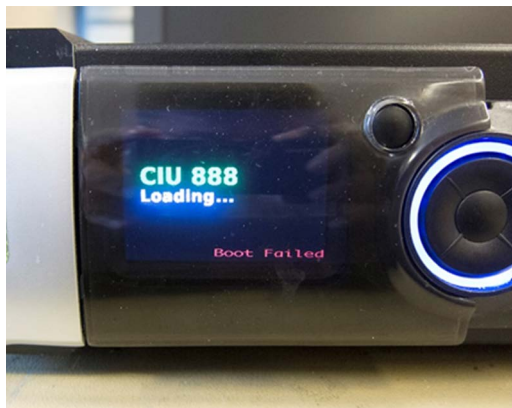
FIGURE 3-4

After switching the CIU 888 on, the error message 'Boot Failed' appears on the CIU 888 display (see FIGURE 3-4).

CIU 888: 'Boot Failed' error message

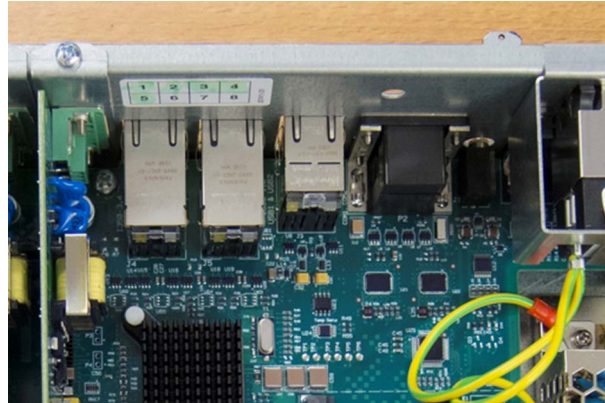
FIGURE 3-5

A fixed serial or Ethernet port of the CIU 888 is not working (see FIGURE 3-5).

CIU 888: Fixed ports

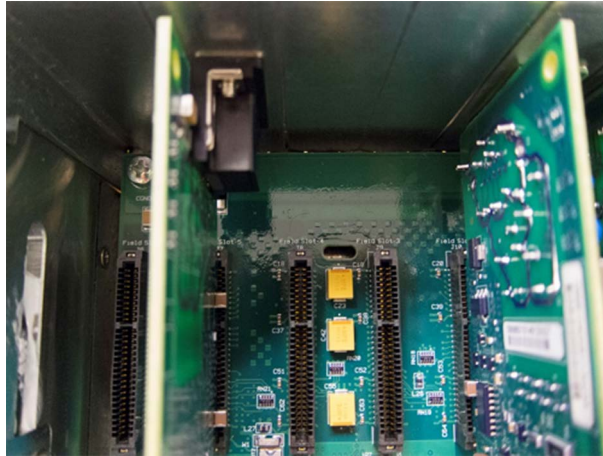
FIGURE 3-6

A field interface card installed in the CIU 888 is not working (see FIGURE 3-6).

CIU 888: Field interface cards

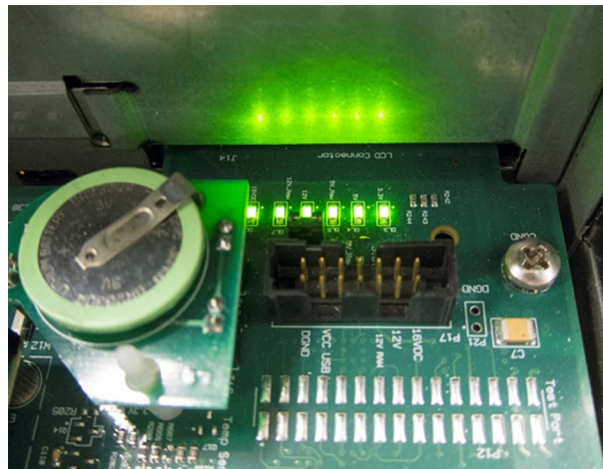
FIGURE 4-1

The lithium battery built into the CIU 888 is used for powering the real-time clock during power-off situations. The battery life is approximately 10 years.

If CIU 888 is un-powered for 35 months after receiving it from factory, the battery would have drained. The battery piggyback board needs to be replaced for proper functioning of the device. See the *Introduction Manual CIU 888 (Part No. 4417591)* for spare parts details.

CIU 888: Lithium battery
